Name Of Dam: LOCH HAVEN LAKE
Location: ROANOKE COUNTY, VIRGINIA
Inventory Number: VA 16102

PHASE I INSPECTION REPORT NATIONAL DAM SAFETY PROGRAM

JANUARY 1981

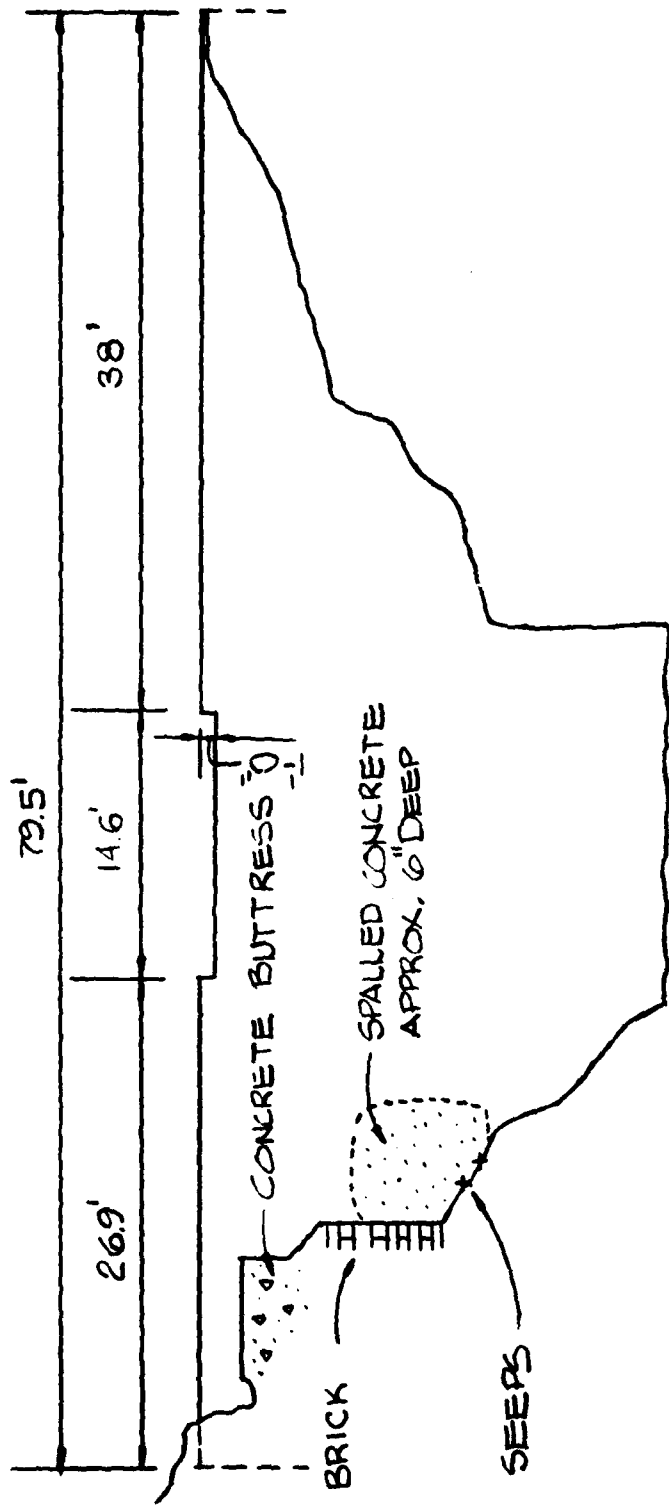
PLATE I

Seepage was observed at two locations along the right abutment contact. These locations are shown on Plate 1. The seepage flow at each location was estimated at 1 gpm. Seepage also was observed 20 ft. from the left abutment at the foundation contact. Flow was very small, little more than a drip, and no estimate of quantity was made.

DOWNSTREAM ELEVATION
LOCH HAVEN LAKE DAM
SCALE 1"=10'

If seeps continue after patching the spalled area at the right abutment, seepage should be monitored to detect increases in flow rate.
